Re: Clean Water Act Pretreatment Inspection

Enclosed is the report for our August 15, 2018 Pretreatment inspection of the Pacific Seafood facility at the above address in Eureka, CA.

**Region 9 Enforcement Division**  
**75 Hawthorne Street**  
**San Francisco, CA 94105**  
**INSPECTION REPORT**

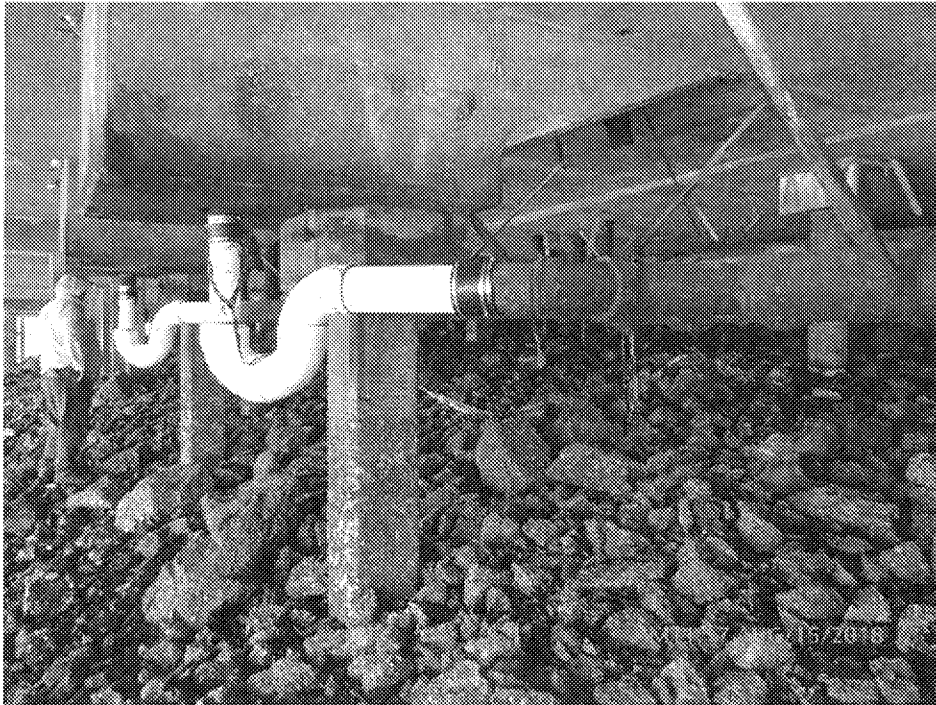
The inspection team began the inspection beneath the facility's dock, during low tide, to observe the location of the deteriorated pipes observed during the January 30, 2018 site visit. The inspection team observed that the facility had replaced all of the leaking p-traps with PVC pipe (Photographs 1 and 2). In addition, the facility had capped the end of the pipe discharging the most significant flow to the Eureka Slough during the previous site visit (Photograph 3) as well as a leak from the pit containing cooked shrimp wastewater observed during the previous site visit (Photograph 4). However, the inspection team observed one leaking pipe (Photograph 5) and multiple uncapped pipes (Photographs 3 and 6) that may be a potential source of discharge. Refer to Items 1 and 2 in the *Areas of Concern* section of this report for additional information. The inspection team also observed an air vent on the PVC pipe that conveys wastewater from the pretreatment system below the dock and to the City sewer (Photograph 7). Refer to Item 3 in the *Areas of Concern* section of this report for additional information.

**Photograph 1.** View of the leaking pipes under the dock, shown in Photographs 11 and 12 of the *City of Eureka PCA Summary Report*. The corroded P-traps had been replaced with PVC pipe.

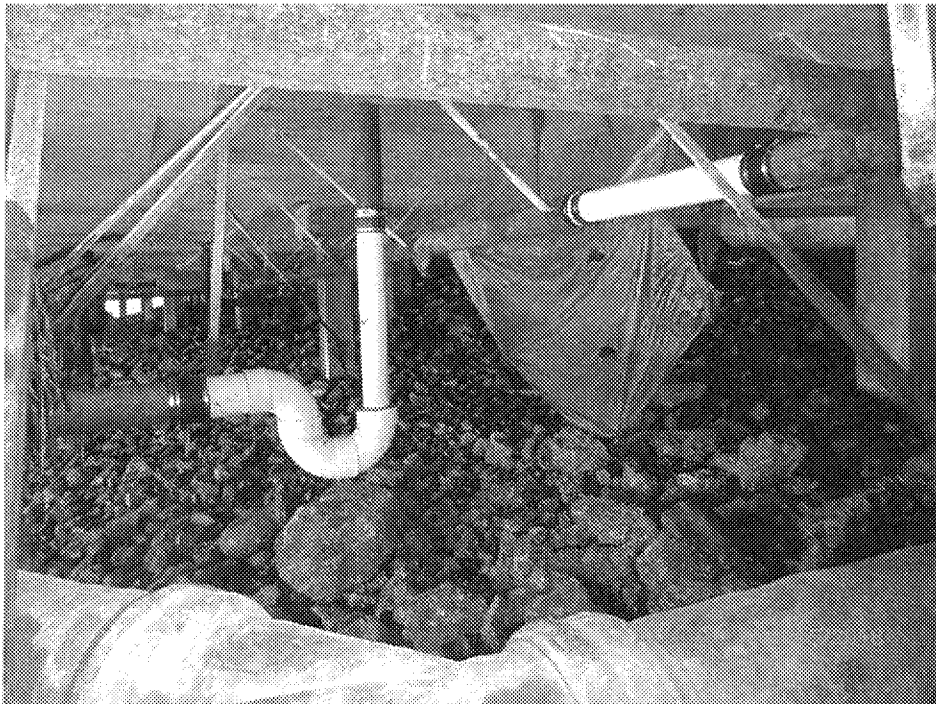
**Photograph 2.** View of the deteriorated pipe under the dock shown in Photograph 14 of the *City of Eureka PCA Summary Report*. The P-trap had been replaced with PVC pipe.

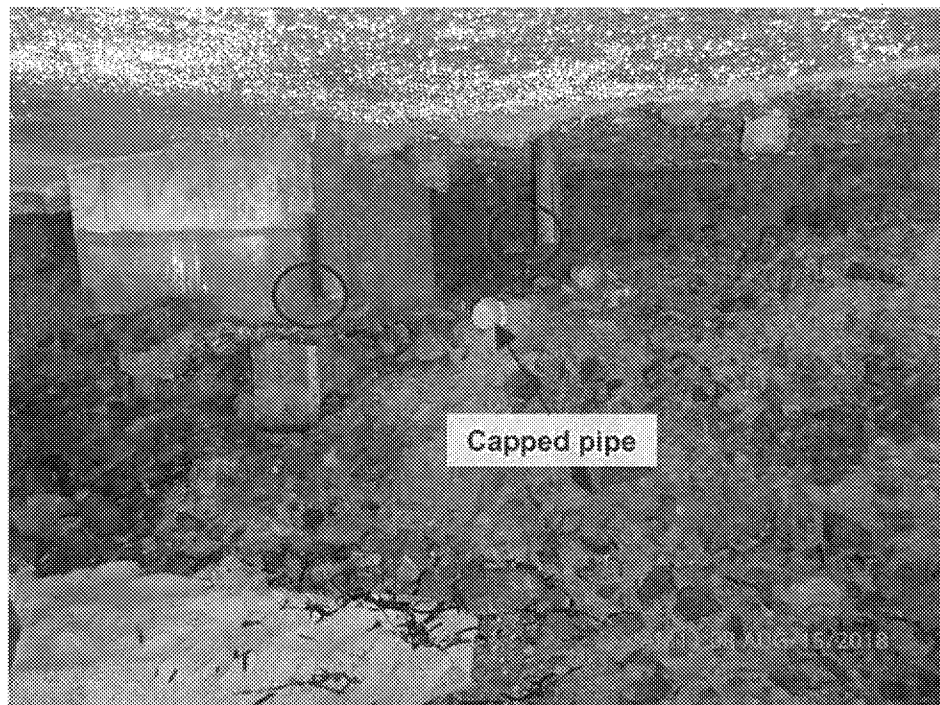
2. Beneath the facility's dock, the inspection team observed multiple vertical pipes (Photographs 3 and 6) coming down from the dock. Although no discharge was observed from these pipes, the pipes were not capped. The inspection team recommended that the facility cap these pipes to remove the potential for discharge.

**Photograph 3.** View of the rusted pipe shown in Photograph 8 of the *City of Eureka PCA Summary Report*. The pipe was capped at the time of the inspection, visible in this photo. Note the two vertical uncapped pipes (circled).

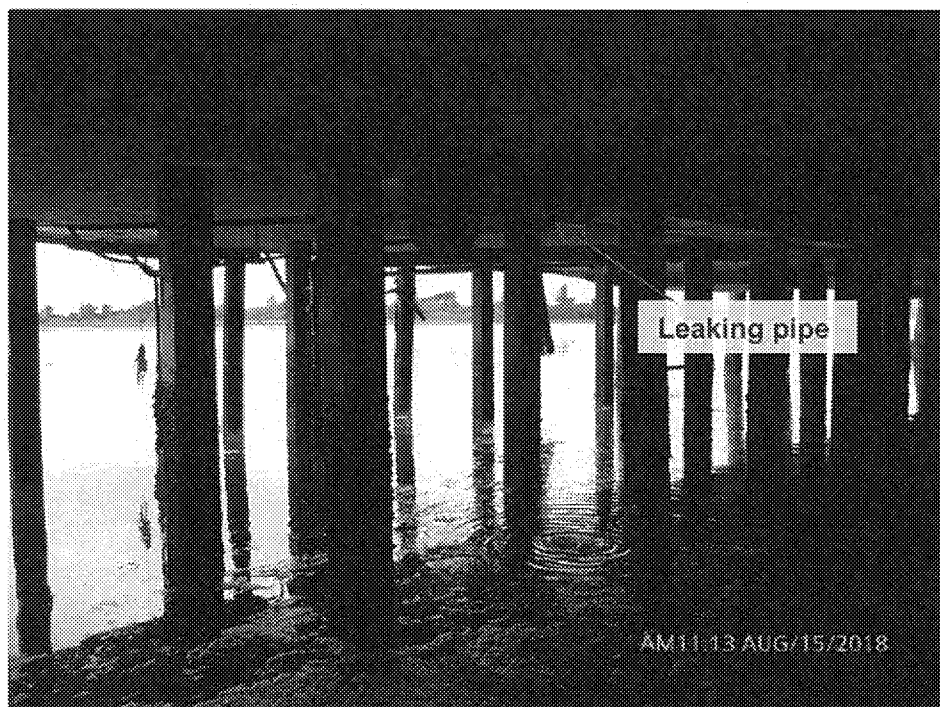
**Photograph 4.** View of the leaking ozone generating system pipe.

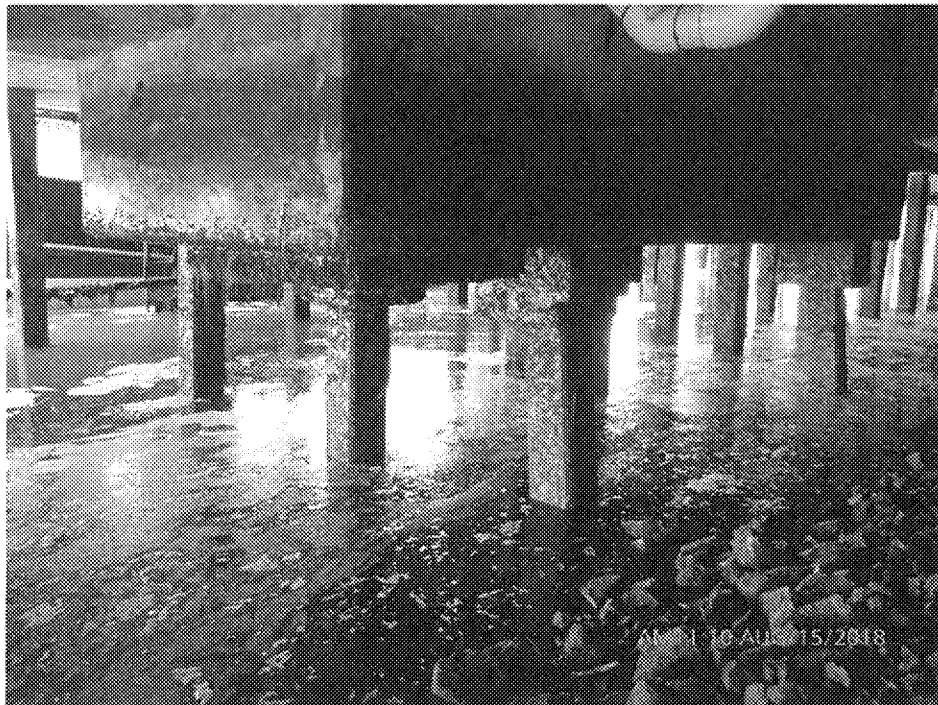
1. The pipe from the ozone generating system (a sanitizer for fish processing) was leaking under the facility's dock (Photograph 5). According to the facility representative, the valve on the pipe (Photograph 36) is located behind the deicing machine and employees may bump the valve as they move past it, which may unlock it and allow this water to discharge. The inspection team recommended that the facility representative put a lock on the valve to prevent the opening of the pipe. Following the inspection, the facility representative emailed a photo of the location of the pipe, showing that the pipe had been removed.

**Photograph 5.** View of the location of the leak under the dock shown in Photograph 10 of the *City of Eureka PCA Summary Report*. This pit captures wastewater that comes into contact with cooked shrimp.

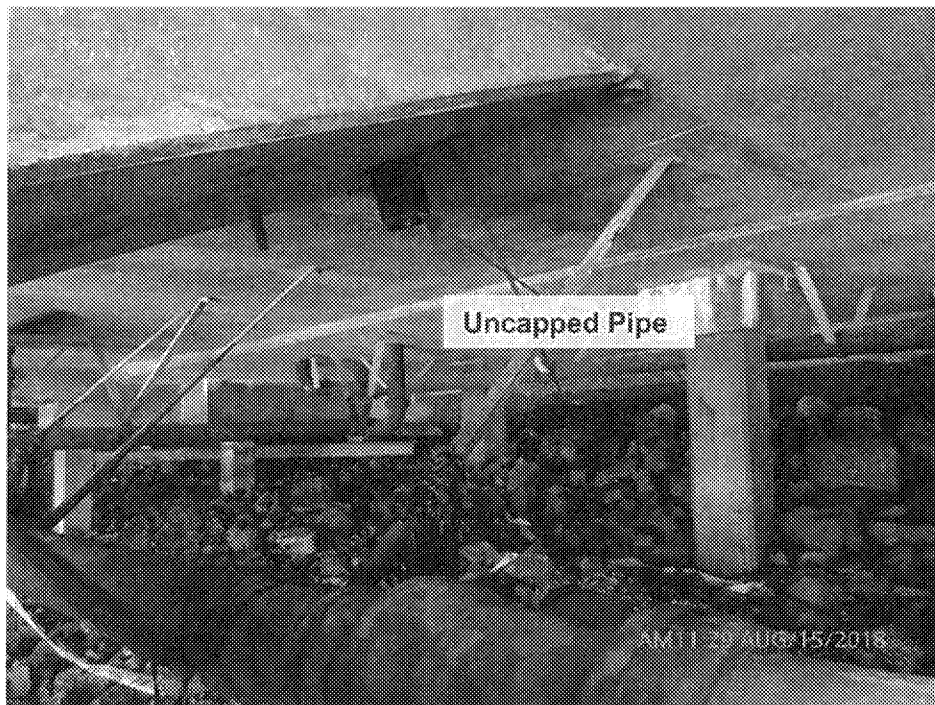
**Photograph 6.** View of a pipe under the dock with no cap.

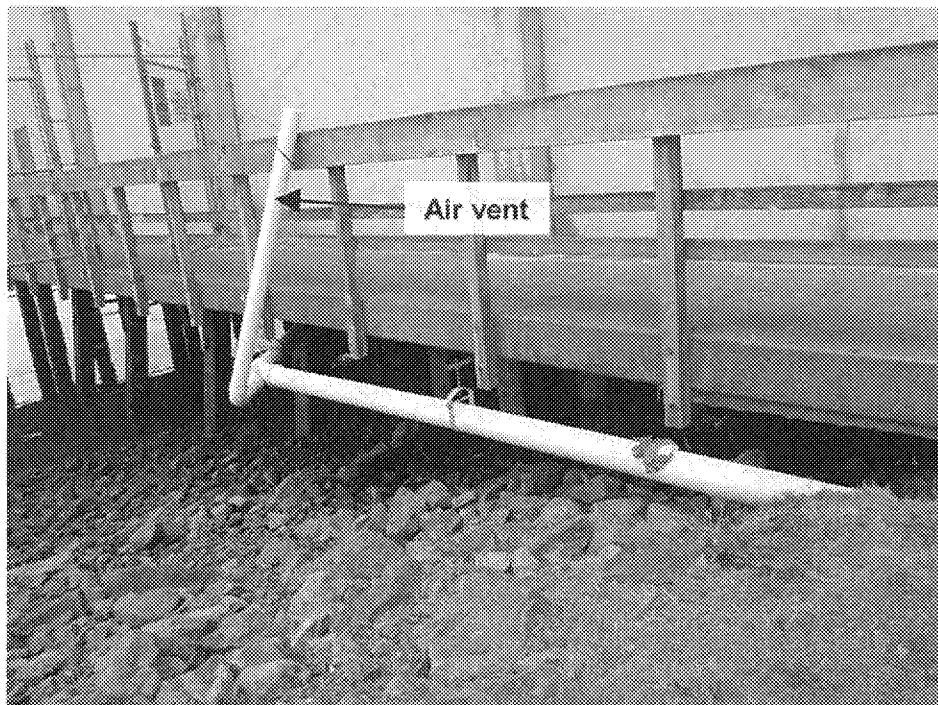
3. The inspection team observed an air vent (Photograph 7) on the white PVC pipe leading to the area underneath the dock. The top of the air vent was positioned at a height that might allow for disposal of process wastewater, chemicals, or other materials. The open PVC pipe could also allow for the capture of rain during a wet weather event, diluting the facility's wastestream. The inspection team suggested that the facility reposition the air vent to prevent either of these issues from occurring.

**Photograph 7.** View of the west side of the facility, facing northeast. The white PVC pipe carries the facility's process wastewater to the POTW. Note the recently installed air vent.

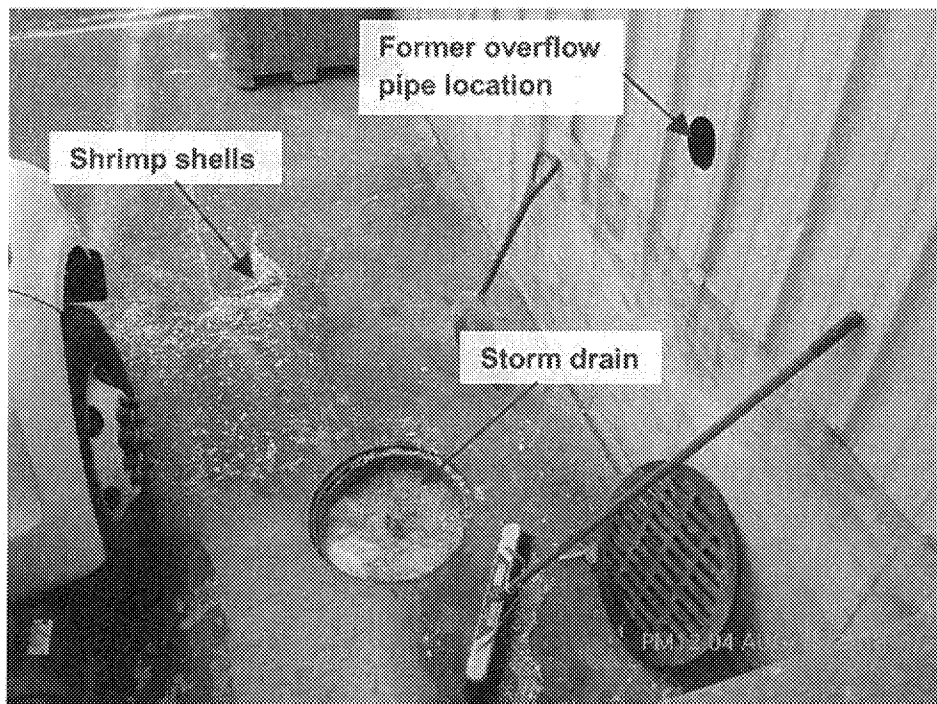
4. Adjacent to the pretreatment building, the facility loads shrimp shells onto a truck to be hauled offsite. Wastewater from the de-shelling process was observed entering a storm drain between the truck and the pretreatment building (Photographs 10 and 11). The grate on the storm drain had been removed and a screen to capture solids was situated over the storm drain. Subsection 54.040.A of the City of Eureka's Stormwater Ordinance (Ordinance No. 705 -C.S) states "No person shall discharge or cause to be discharged into the storm drainage facilities or watercourses any materials, including but not limited to pollutants or waters containing any pollutants that cause or contribute to a violation of applicable water quality standards, other than storm water." Discharge of the shrimp process wastewater to the storm drain is an unpermitted discharge.

**Photograph 10.** View of the storm drain, shown in Photograph 4 of the *City of Eureka PCA Summary Report*. Process wastewater from the shrimp de-shelling process was entering the storm drain.

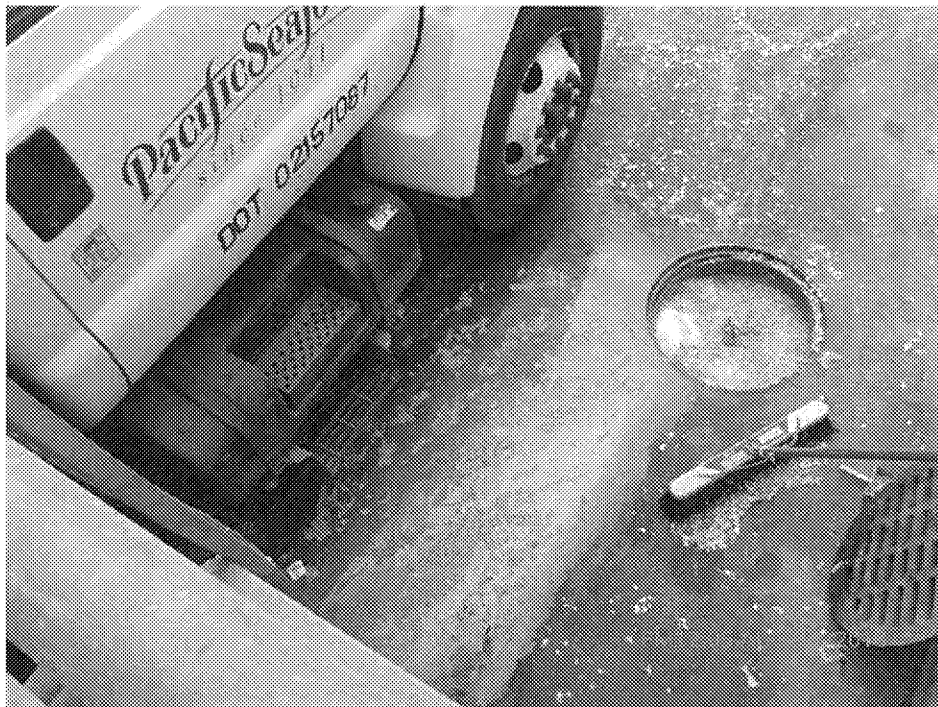
**Photograph 11.** Another view of the storm drain shown in Photograph 10. The truck visible at the left side of the photo is capturing shrimp shells.

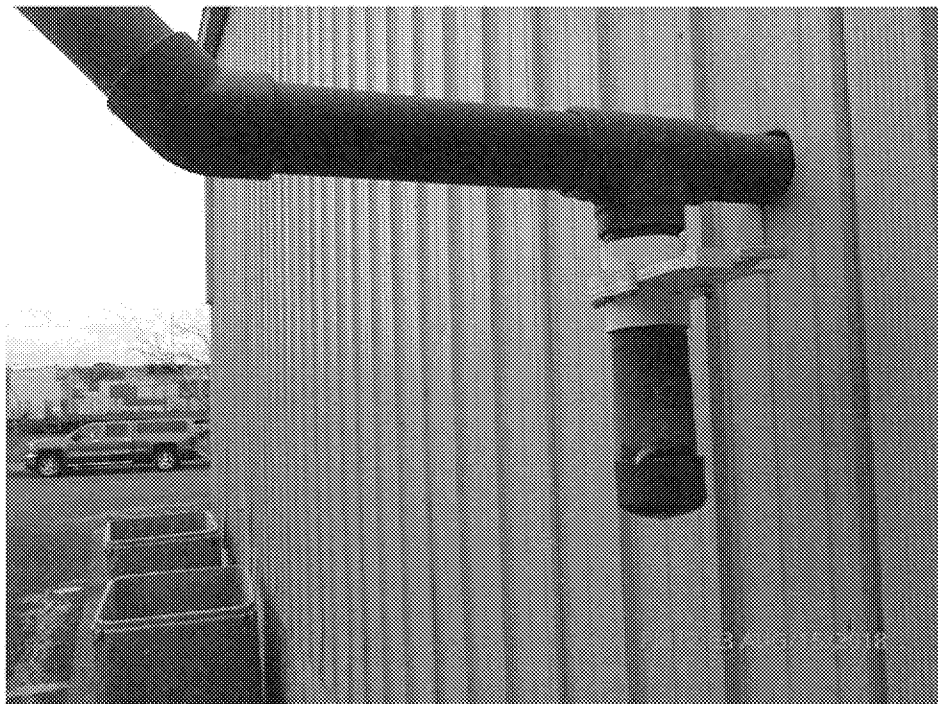
report for additional information. The inspection team observed that the overflow pipe noted during the previous site visit had been removed (Photograph 10). In addition, the potential bypass line directly adjacent to the pretreatment building had been shortened and capped (Photograph 12). The other bypass line was still in place. The inspection team also observed the point at which the storm drain discharged to the Eureka Slough (Photographs 13 and 14).

**Photograph 12.** View of the pretreatment system bypass line outside of the pretreatment building, shown in Photograph 1 of the *City of Eureka PCA Summary Report*. At the time of the inspection, the bypass line had been capped.

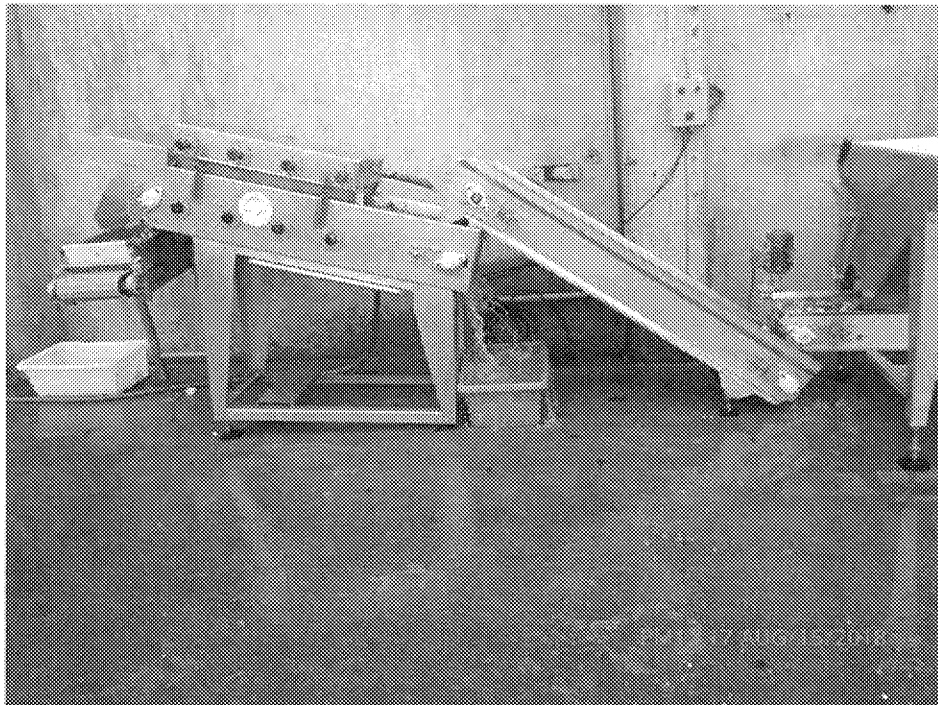
5. The facility performs initial processing of fish, oysters, and crabs on the facility's dock, located on the north side of the building. At the time of the inspection, the inspection team observed oysters being rinsed (Photograph 15). The facility uses City water to rinse

**Photograph 15.** View of the oyster rinsing area.

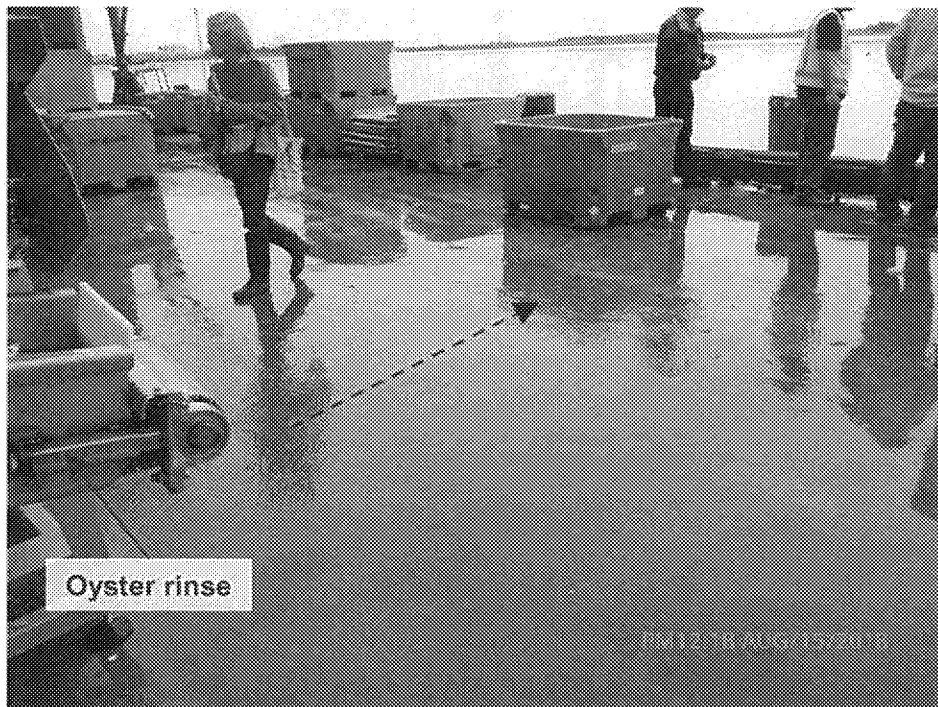
the oysters. This rinse water flows off the side of the dock into the Eureka Slough (Photograph 16).

The facility does not have a permit to discharge to waters of the State and waters of the United States.

**Photograph 16.** View of the oyster rinse water flowing off the side of the dock. The dashed line indicates the direction of flow of the oyster rinse water towards the side of the dock.

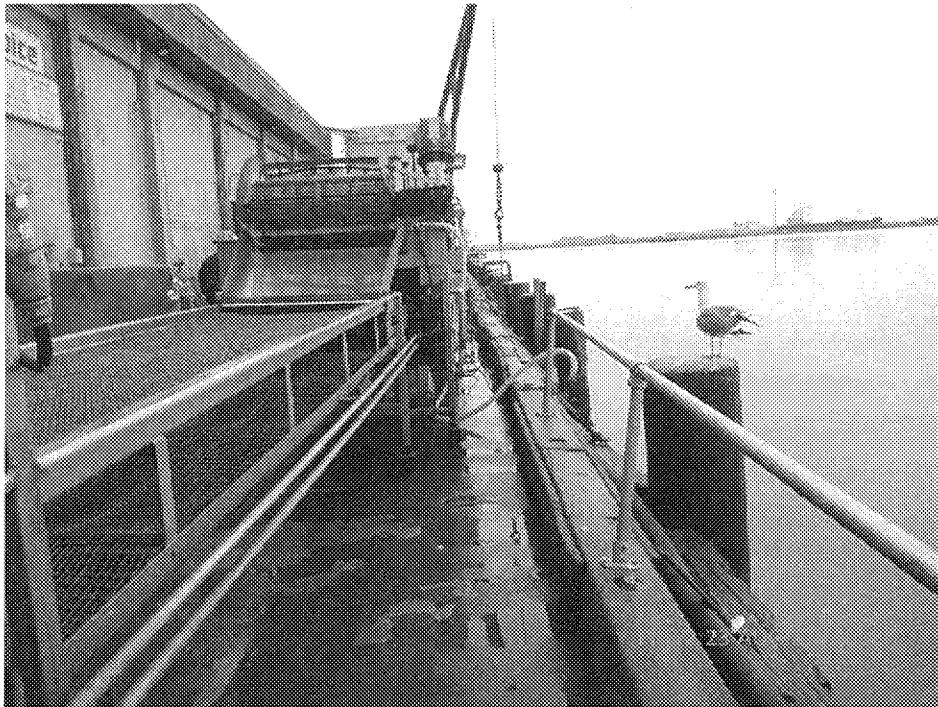
The facility has a deicer on the dock (Photograph 17). The bucket of fish from the boat goes into the deicer along with water from Eureka Slough and some ice. The fish sink and are transported along a conveyer system into a tote. The water from the Eureka Slough and ice flow off the side of the dock and back into the Eureka Slough.

**Photograph 17.** View, facing southwest, of the deicer located on the facility's dock.

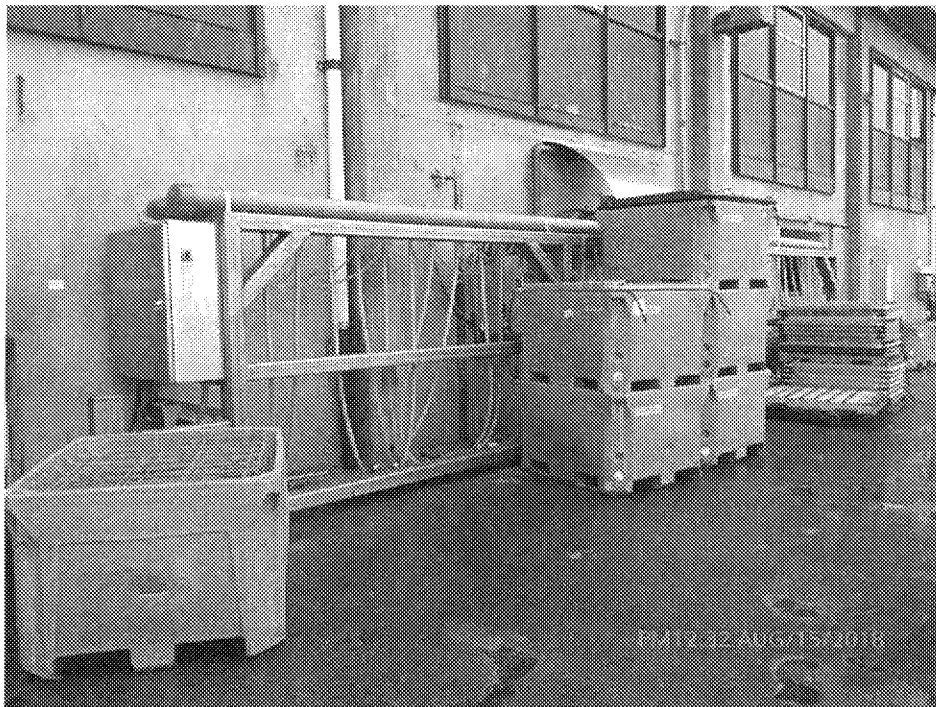
In addition, the facility pumps up water from the Eureka Slough into totes containing live crabs (Photograph 18). Overflow from the totes flows onto the dock and off the side of the dock, back into the Eureka Slough.

**Photograph 18.** View of the outdoor crab processing area. Live crabs are placed in the totes and the hoses located behind the totes provide a flow of fresh water from the Eureka Slough into the totes.

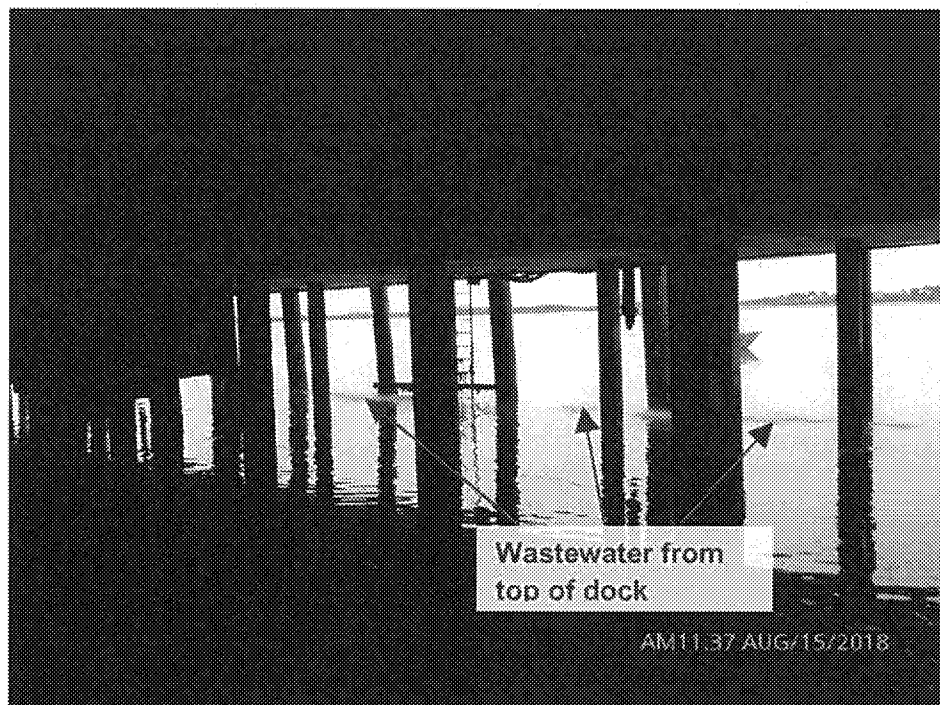
**Photograph 19.** View of the water coming off the top of the dock into the Eureka Slough.

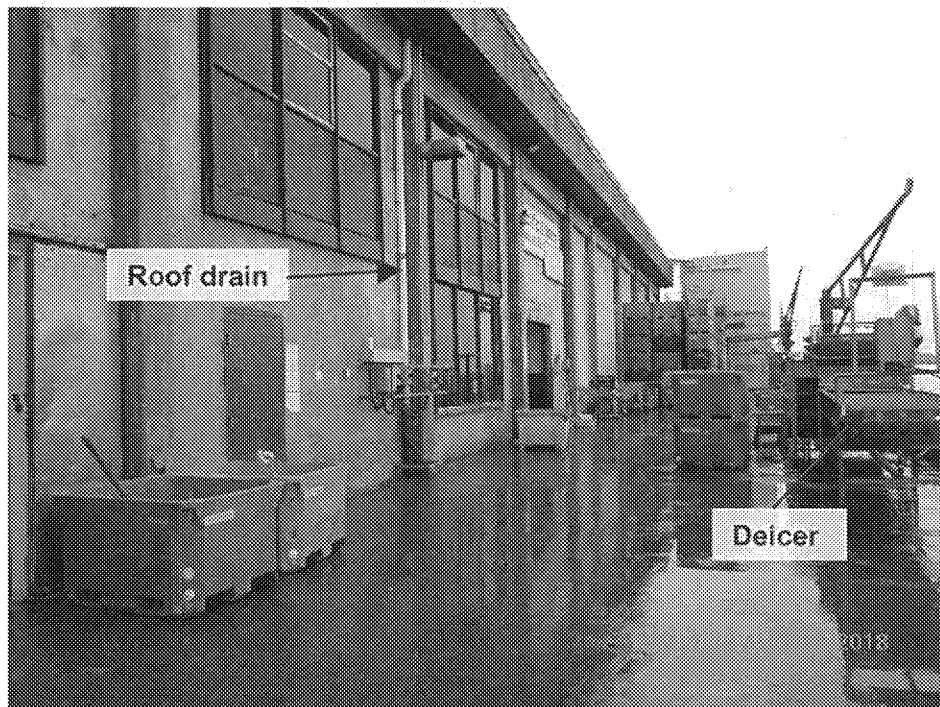
6. On the facility's dock, the inspection team observed three pipes, identified as roof drains by the facility representative, that appeared to go beneath the dock (Photograph 20). The inspection team requested that the facility identify where these pipes discharge, whether they connect into the sanitary sewer, or discharge to the Eureka Slough.

**Photograph 20.** View of the dock. The deicer shown in Photograph 17 is visible at the right side of the photo. One of the facility's roof drains is also visible at the center of the photo.

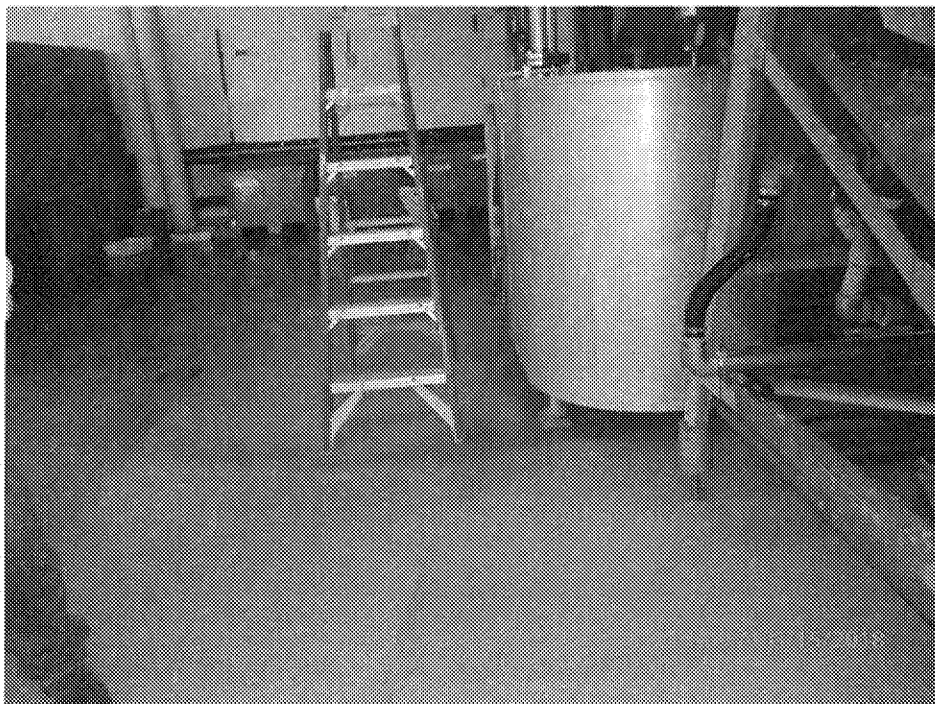
7. In the shrimp processing area, the inspection team observed the overflow of wastewater from the bermed shrimp processing area entering a floor drain, which goes directly to the City sewer (Photographs 22 and 23). The federal pretreatment regulations at 40 CFR 403.17(d) prohibit bypass of treatment unless the "[b]ypass was unavoidable to prevent loss of life, personal injury, or severe property damage"; "there were no feasible alternatives to the bypass..." and the permittee "submitted notices as required" by 40 CFR 403.17(c). Furthermore, Part 4.D of the facility's permit prohibits bypass of treatment unless the permittee has submitted the required notification as required by the permit. The facility is required to ensure that shrimp process wastewater is directed to the facility's pretreatment system and does not bypass the pretreatment system.

**Photograph 22.** View of wastewater from the shrimp processing area entering a floor drain. According to the facility representative, wastewater entering this floor drain goes directly to the City sewer and does not go through the pretreatment system.

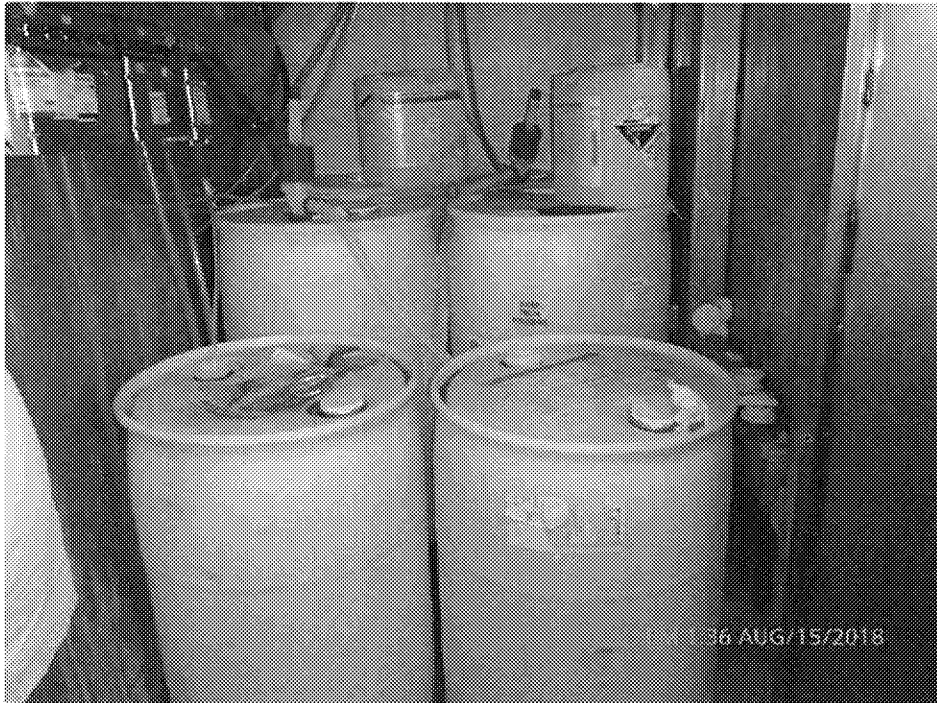
9. The facility was storing acidic and caustic chemicals adjacent to one another in the facility's indoor bulk chemical storage area without secondary containment (Photographs 24 and 25). Part 1.C of the facility's discharge permit states, "[t]he permittee shall remove or double-contain any hazardous materials, stored near drains, in a manner which will ensure that accidental spills or leaks will not enter the storm drain or sanitary sewer." It is recommended that the facility separate the acid and caustic chemical drums to prevent a reaction of incompatible chemicals. The facility is required, as stipulated in the discharge permit, to install secondary containment for the chemical drums in the indoor chemical storage area to prevent a discharge of chemicals to the floor drain, which leads directly to the City sewer.

**Photograph 24.** View of the facility's indoor bulk chemical storage area, located near the crab processing room. The two drums in the foreground were not in secondary containment.

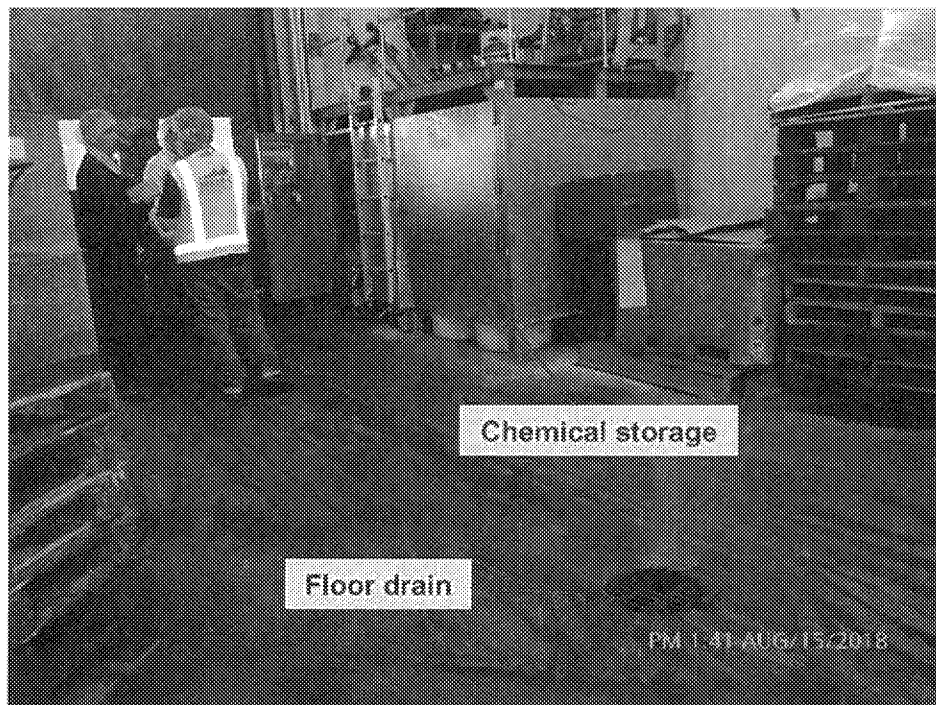
**Photograph 25.** View of the indoor bulk chemical storage area shown in Photograph 24 and a floor drain. Note the two chemical drums in the chemical storage area were not in secondary containment.

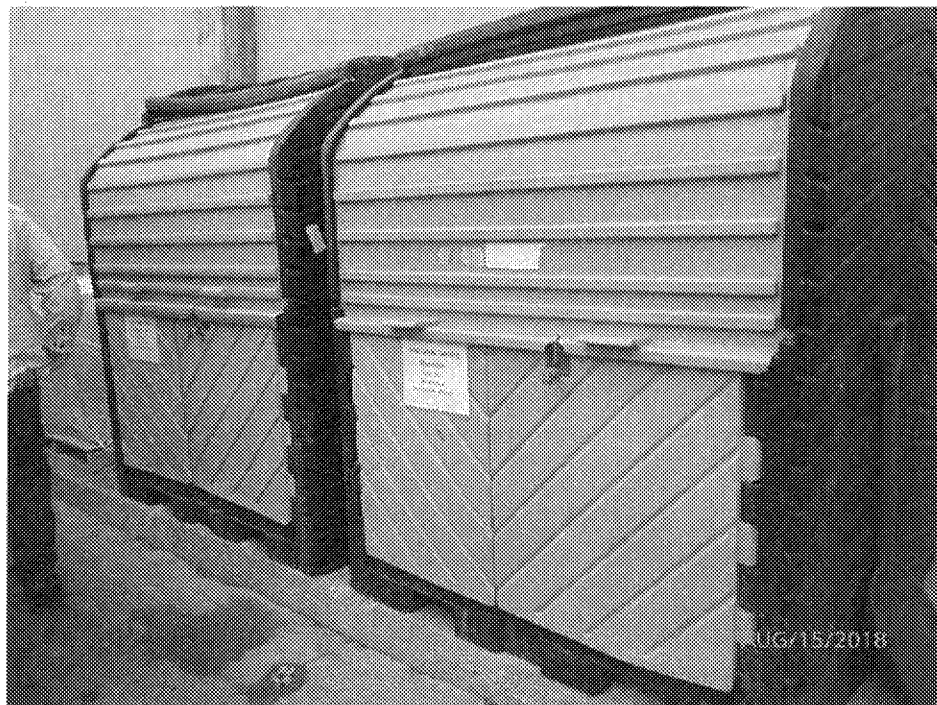
10. The facility was lacking secondary containment in the facility's outdoor chemical storage area (Photographs 26-28). Part 1.C of the facility's discharge permit states, "[t]he permittee shall remove or double-contain any hazardous materials, stored near drains, in a manner which will ensure that accidental spills or leaks will not enter the storm drain or sanitary sewer." The facility is required, as stipulated in its discharge permit, to ensure that all chemical drums in the outdoor chemical storage area have secondary containment.

**Photograph 26.** View of the outdoor bulk chemical storage area.

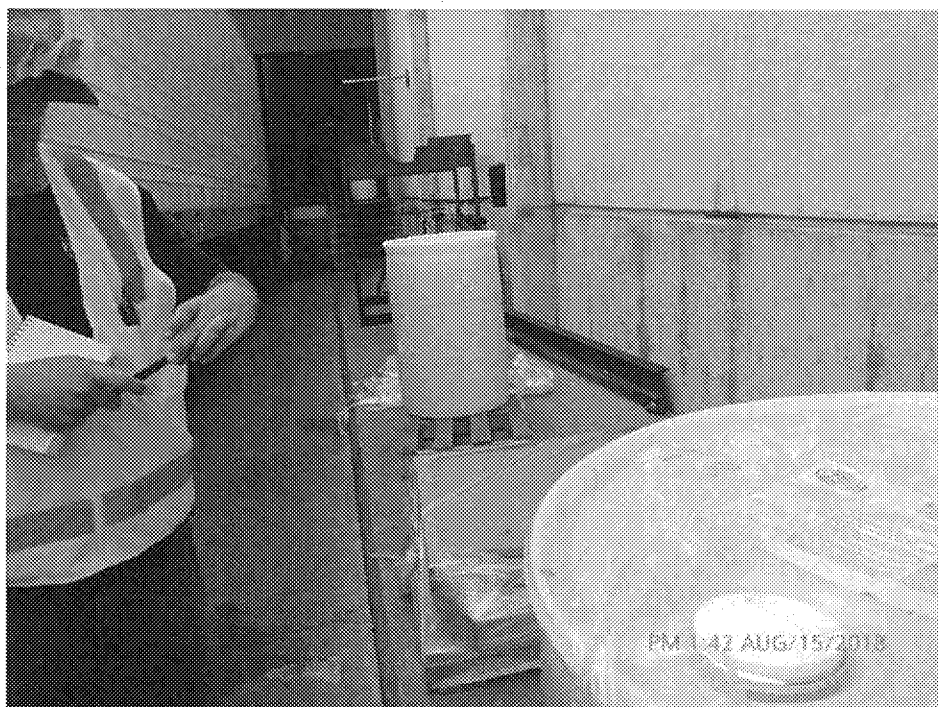
**Photograph 27.** View of chemical storage drums located outside the facility's production building and not within secondary containment or in a covered area.

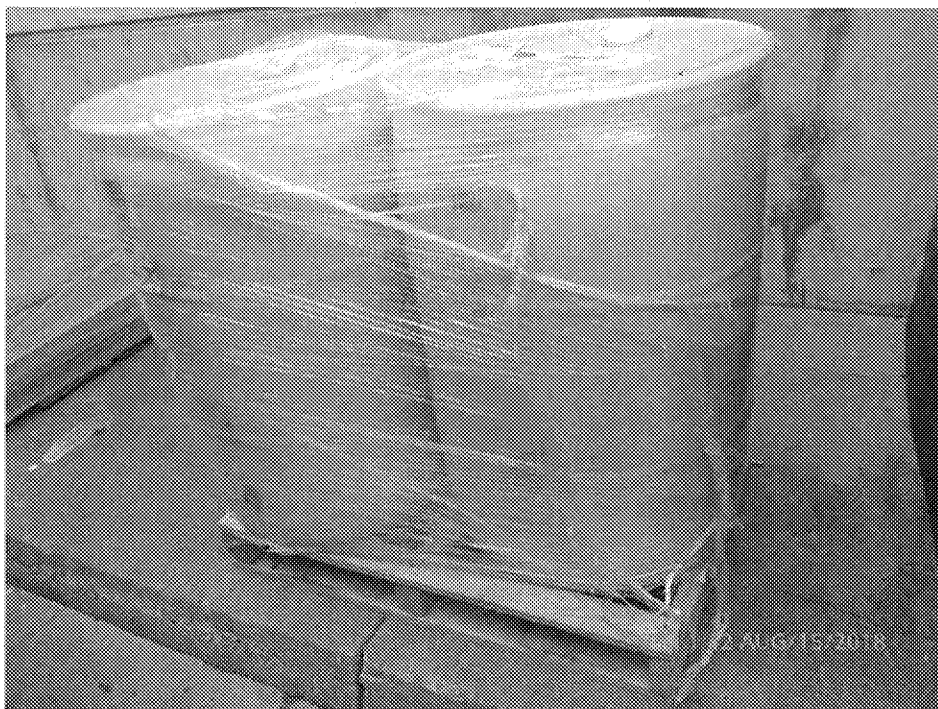
**Photograph 28.** Another view of chemical storage drums located outside the facility's production building lacking secondary containment and a covered structure.

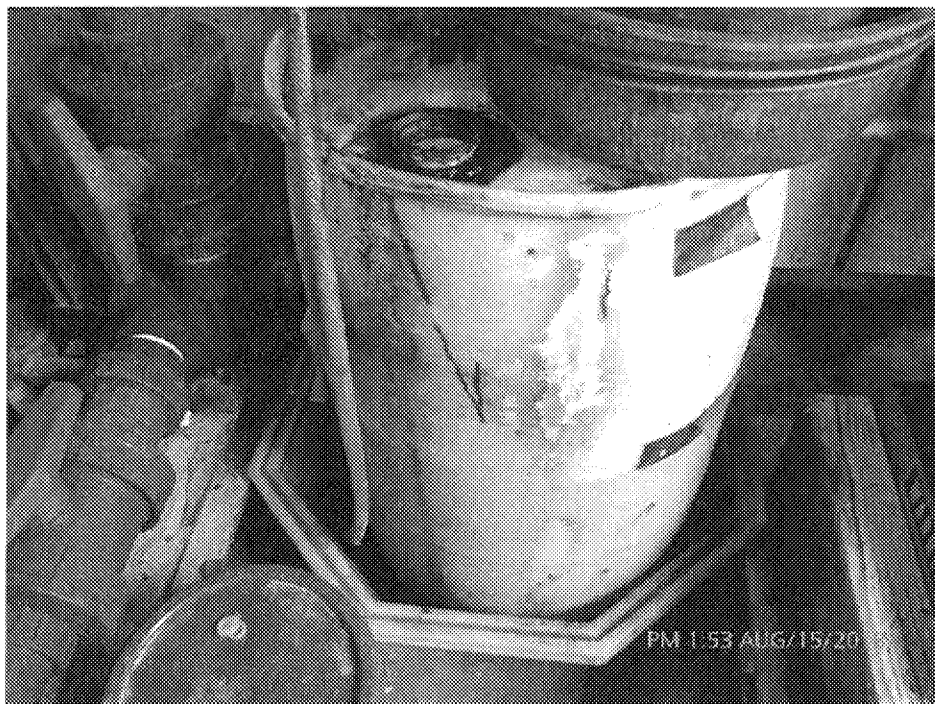
11. The facility was storing a drum of used oil in the pretreatment building (Photograph 30). The accumulation start date on the label was October 4, 2015 (Photograph 31). It is recommended that the facility ensures that hazardous waste is hauled offsite in accordance with the hazardous waste generator standards. Part 1.F of the facility discharge permit states, "[a]ny wastes generated by the permittee which are determined to be hazardous under the California Administrative Code, Title 22, Chapter 11, Articles 2 and 3, shall be recycled or disposed of in accordance with Local, State, and Federal Law."

**Photograph 30.** View of a 55-gallon drum of used oil located inside the eastern door of the pretreatment building.

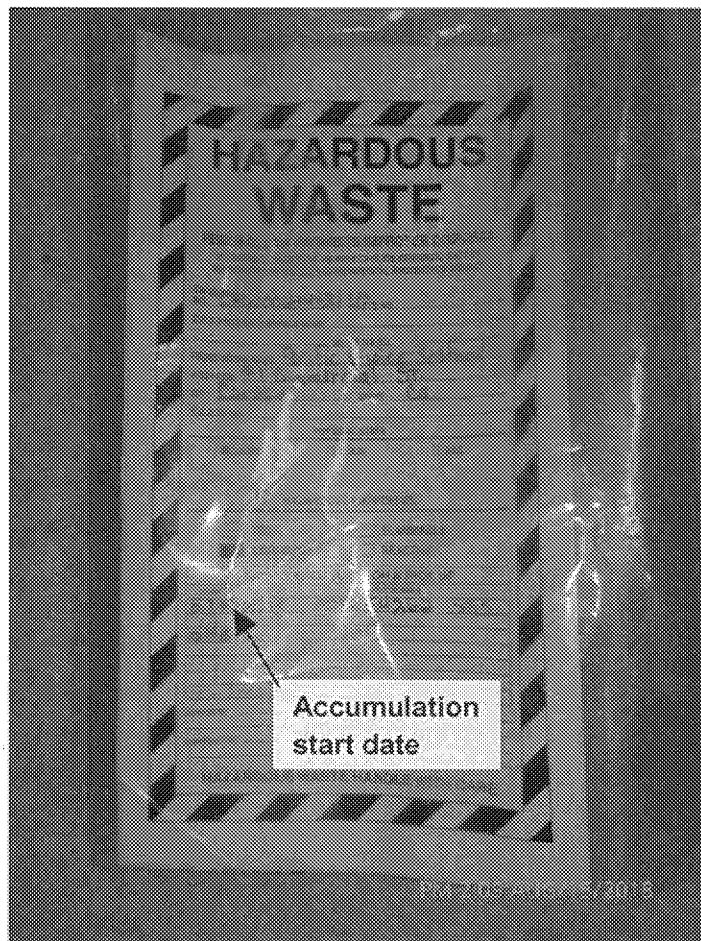
**Photograph 31.** View of the hazardous waste label located on the wall above the used oil drum shown in Photograph 18. The label had an accumulation start date of 10/4/2015.

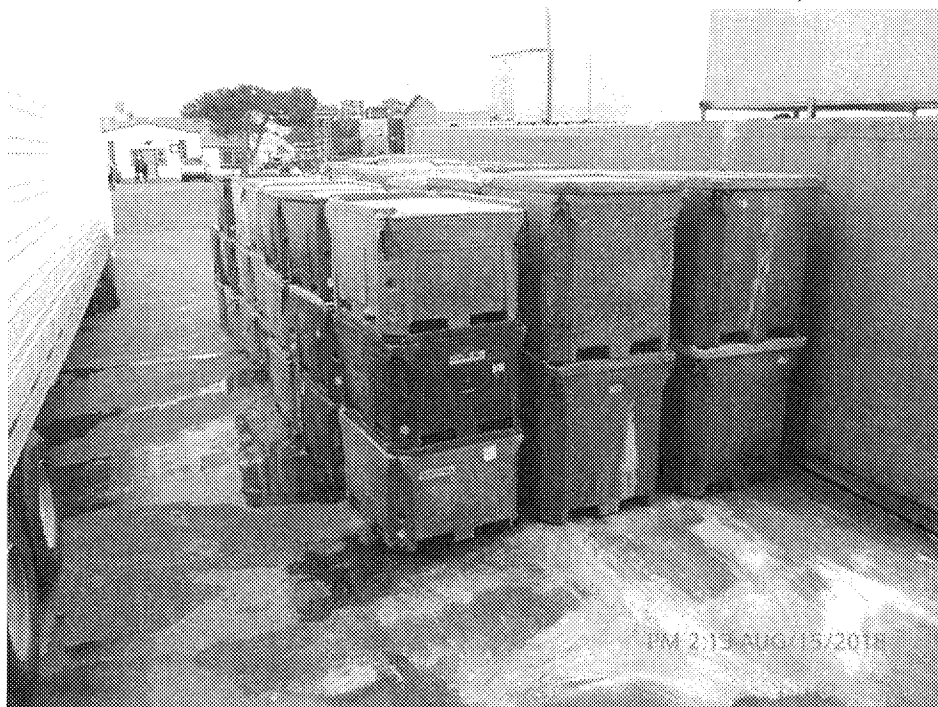
12. The inspection team observed a storm drain in the loading dock area (Photograph 35). Process wastewater from shrimp processing was observed near the storm drain (Photographs 32-34). In addition, oily water was observed on the platform above the driveway with the storm drain (Photograph 33). During a rain event, this wastewater has the potential to reach the storm drain. Subsection 54.040.A of the City of Eureka's Stormwater Ordinance (Ordinance No. 705 -C.S) states "No person shall discharge or cause to be discharged into the storm drainage facilities or watercourses any materials, including but not limited to pollutants or waters containing any pollutants that cause or contribute to a violation of applicable water quality standards, other than storm water." In

**Photograph 32.** View of fish bins stored in the facility's loading dock. Wastewater was observed flowing from this area to the storm drain shown in Photograph 35.

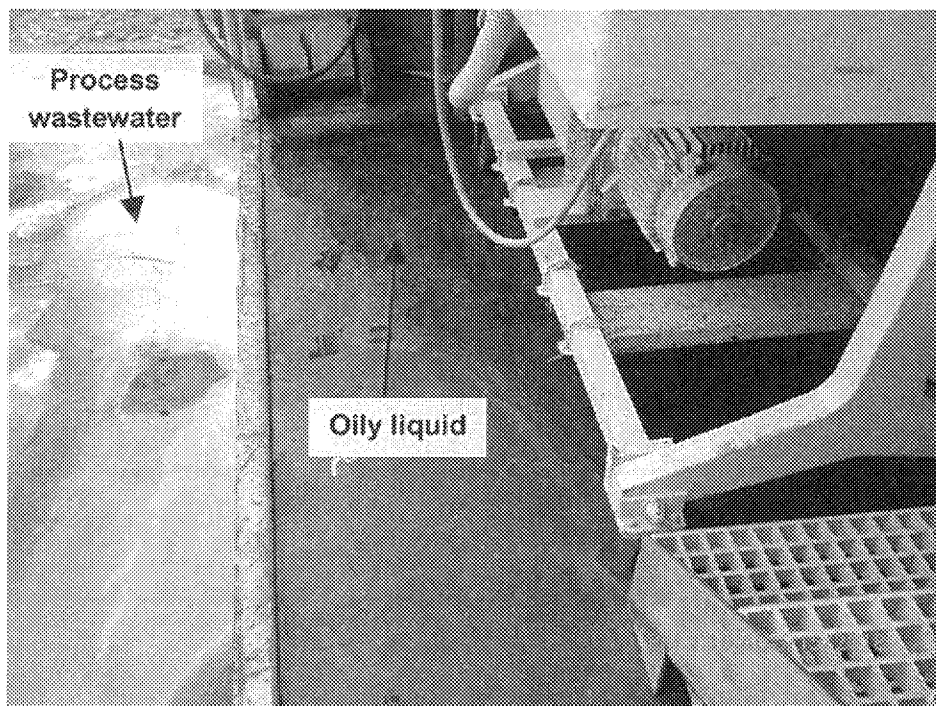
addition, Part 1.C of the facility's discharge permit states, "[t]he permittee shall remove or double-contain any hazardous materials, stored near drains, in a manner which will ensure that accidental spills or leaks will not enter the storm drain or sanitary sewer."

**Photograph 33.** View of process wastewater and oily liquid present in the facility's loading dock.

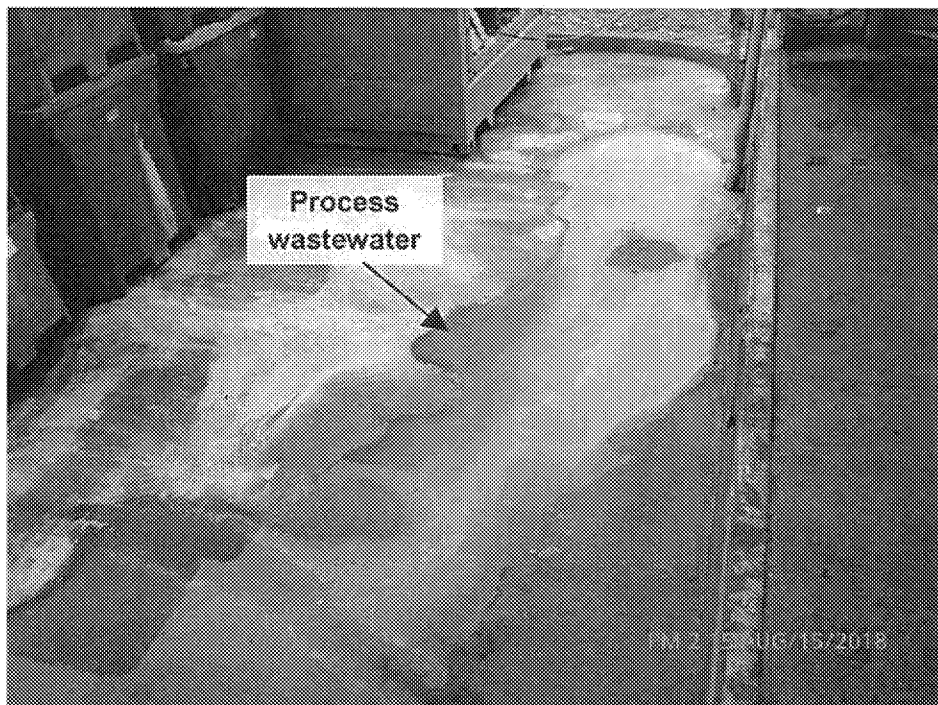
**Photograph 34.** Another view of the process wastewater shown in Photograph 35.

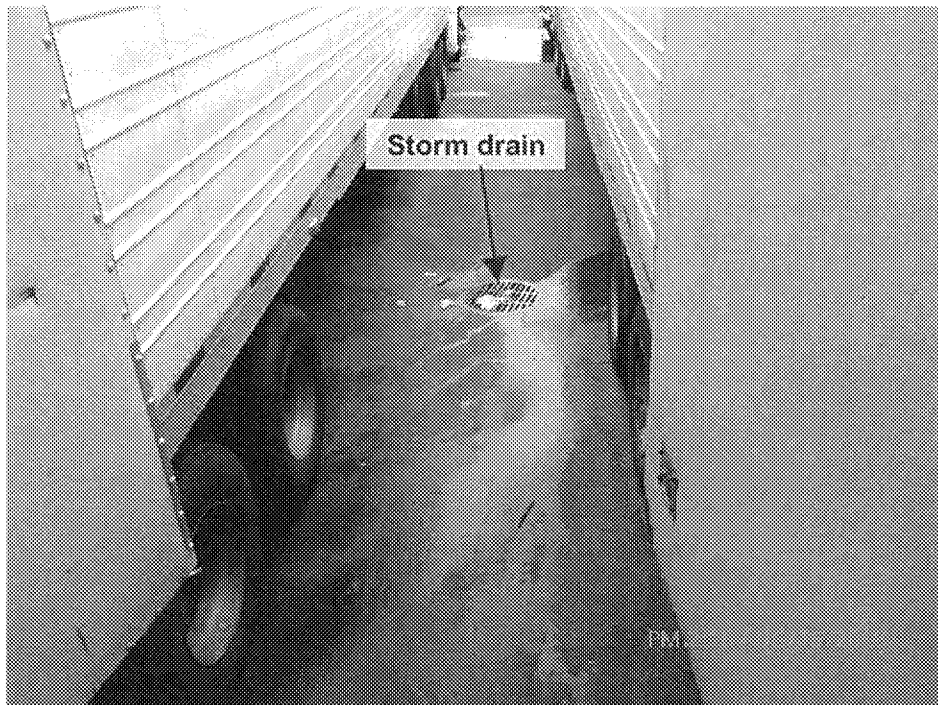
**Photograph 35.** View of a storm drain located nearby the locations shown in Photographs 32 – 34. Liquid is visible entering the storm drain.
